**Flood Control Project Maintenance  
Levee Inspections**

**Maintenance Issue Types Only, Levee Inspection Report By Mile - Fall 2018**

**Reclamation District No. 2095 Paradise Cut**

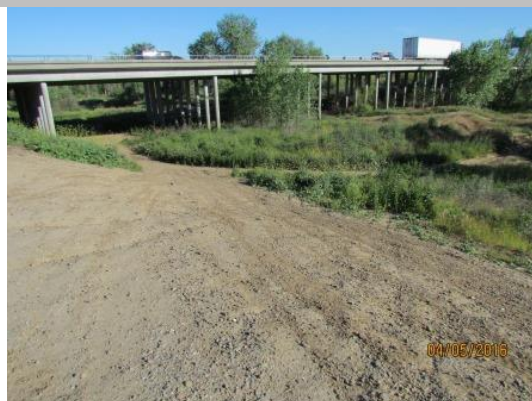
Photo 1 of 1 : FA\_2018\_RD2095\_322\_10\_20180911\_00001.jpg

LM Start	0.15	Rating **	A/W	Issue No.	10
LM End	0.15	Issue Type +	Ma	Location *	WS
Category	Earthen Levee			GPS Latitude/Longitude	
				Start	End
Item	Slope Stability			37.769997°	37.769997°
				-121.325055°	-121.325055°
DWR ID	DWR_RD2095_01_f_2015_10				
Comment Code					
S3 : Repair the levee slope damaged by vehicle traffic and prevent access where possible.					
Inspector Comment					
LMA is actively controlling access. The slope appears to be stable and should be monitored for possible erosion.

View of the vehicle tracks on the waterside levee slope.

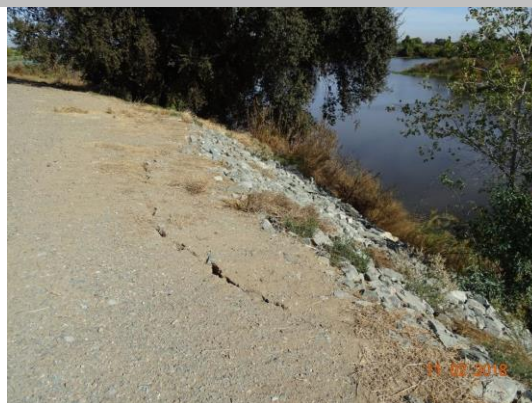
Photo 1 of 1 : FA\_2018\_RD2095\_323\_10\_20181105\_00020.jpg

LM Start	1.33	Rating **	M	Issue No.	10
LM End	1.33	Issue Type +	Ma	Location *	WS
Category	Earthen Levee			GPS Latitude/Longitude	
				Start	End
Item	Cracking			37.744904 °	37.744904 °
				-121.297679 °	-121.297679 °
DWR ID	DWR_RD2095_02_f_2018_10				
Comment Code					
CR1 : Monitor and have inspected by geotechnical engineer.					
Inspector Comment					
Large crack on the waterside shoulder at previous erosion repair site. Recommend getting a geotechnical engineer to evaluate the crack.

View of cracking on waterside shoulder. Fall 2018.

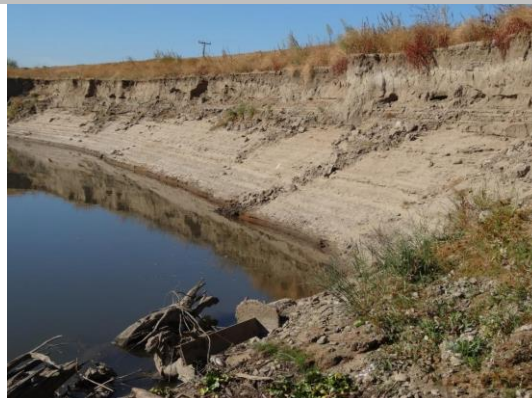
Photo 3 of 4 : FA\_2018\_RD2095\_323\_1\_20180911\_00003.jpg

Close view of the erosion.

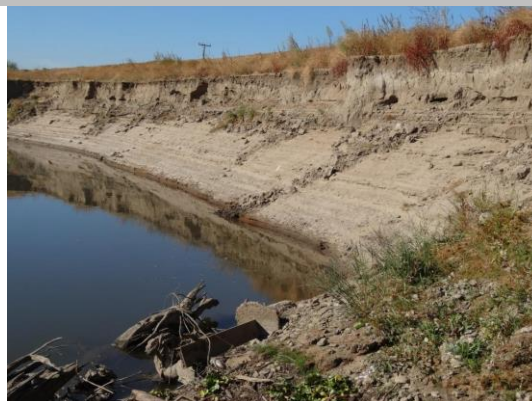
Photo 4 of 4 : FA\_2018\_RD2095\_323\_1\_20180911\_00004.jpg

Close view of the erosion.

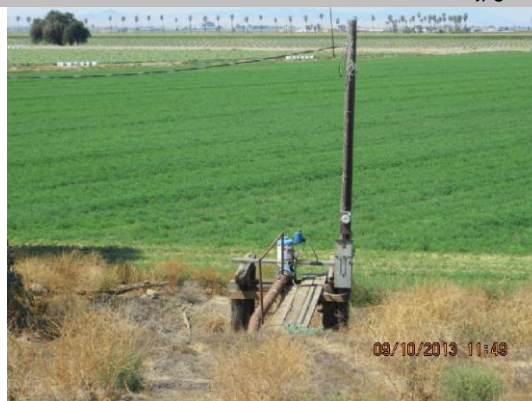
Photo 1 of 2 : UCIP\_FA\_2018\_19871\_33778.jpg

LM Start	2.38	Rating **	A/W	Issue No.	945
LM End	2.38	Issue Type +	Ma	Location *	
Category	Supplemental			GPS Latitude/Longitude	
				Start	End
Item	DWR UCIP LMA Responsibility			37.731313 °	37.731313 °
				-121.298298 °	-121.298298 °
DWR ID	21644				
Comment Code					
Inspector Comment					
FS_ID:19871 DS_ID:21644 EP_NO: N/A Repair Type: No Action Needed Crossing Status: Found UCIP Comments: FIELD_STRUCT_DESC: 8-inch steel drainage pipe through the levee, 3 feet below the crown. Pump in drainage ditch on the landside (LS). Vent pipe at the waterside (WS) toe. 1.5-inch galvanized iron electrical conduit through the levee at the same location. Service pole with a switch box and meter on the LS. [Additional Reference(s): DWR Levee Log, 2005. USACE San Joaquin O&M Manual 11, 1968, (HLM 2.41)]. FS Date: 9/10/2013

Pump on metal pier off LS toe.

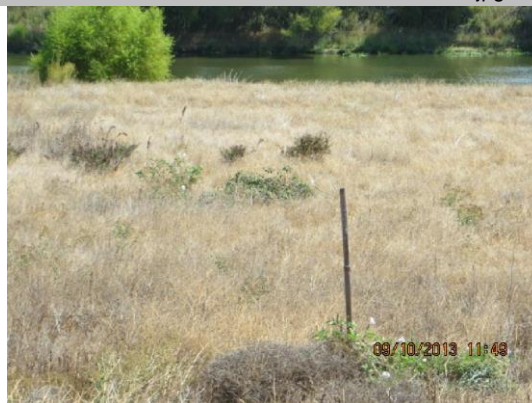
Photo 2 of 2 : UCIP\_FA\_2018\_19871\_33777.jpg

Vent standpipe on WS toe.
